DERELICT BOATS IN DOG RIVER, ALABAMA

Tela V. O'Rourke, Department of Earth Sciences, University of South Alabama, Mobile, AL 36688. E-MAIL: tkv601@jaguar1.usouthal.edu. Derelict Boats in Dog River, Alabama.

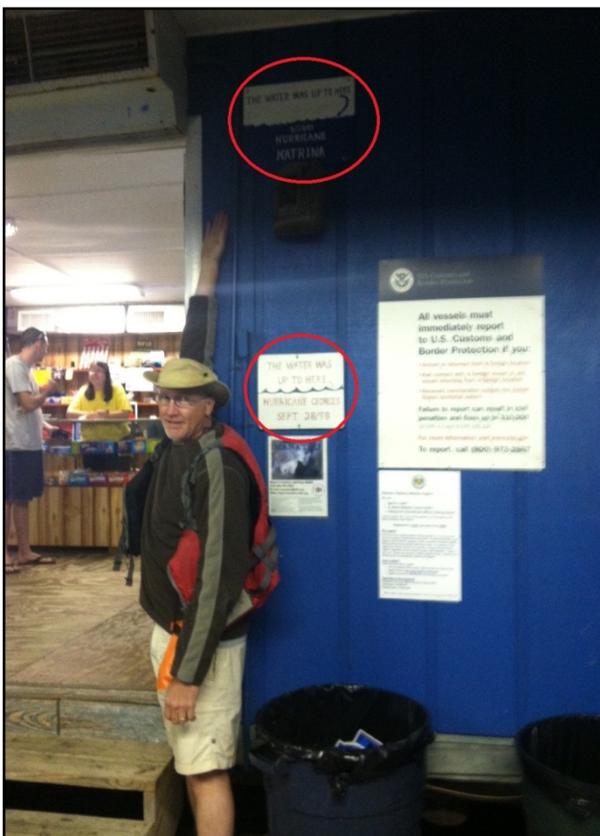
Figure 1. Donald Brinkman, who stands at 6’1”, here at the Grand Mariner off of Dog River indicates the height of storm surge during past tropical storm events. The bottom circle is the storm surge height of H. Georges in 1998, which peaked at 12ft above sea level. The top circle is H. Katrina in 2005, where the storm surge reached 16ft above sea level in this area.

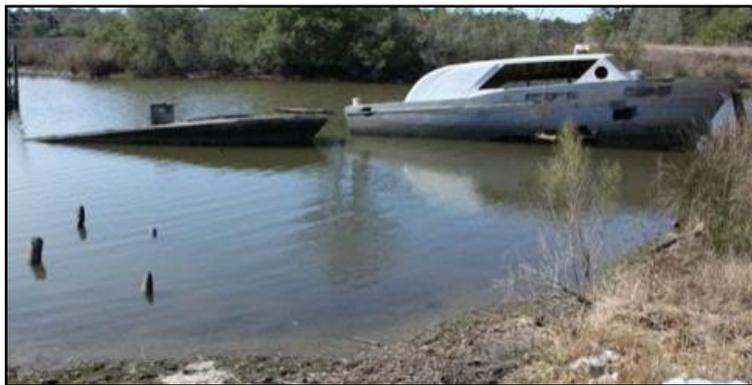
Figure 2. Two abandoned boats lie in a canal located directly off of Dauphin Island Parkway. Plant growth and birds' nests on the crafts indicate the lengthy time the derelict boats have rested here.

The boats abandoned were in the marina or in small canals. All had the appearance of years of decay and neglect. An example of boat conditions can be seen in Figure 2. Decaying boats create homes for birds' nest and plant life when neglected in an area for a long period without use.

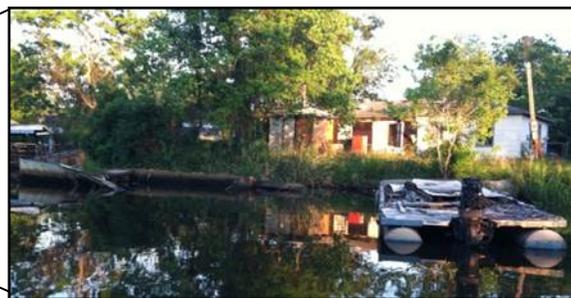
Figure 3. The vessels above are located near the mouth of Eslava Creek. An old yacht and burned pontoon boat are left neglected in this low-income
