ESLAVA CREEK PARKWAY COLLAPSE THREAT

Zach Warner

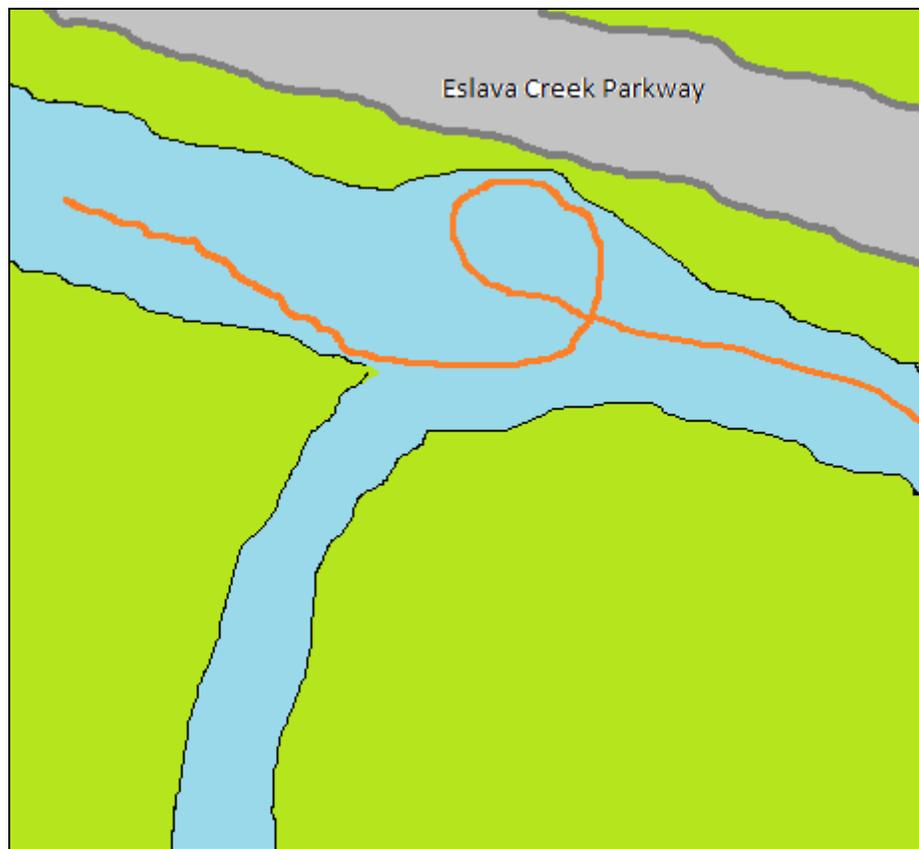
Figure 2.
The orange line represents the orange's path as it traveled down Eslava Creek and passed the drainage ditch entrance. This test confirmed that the current is a main cause of the north bank erosion.

This whirlpool current appears to be the main reason for localized erosion on the north bank of Eslava Creek. The harder the rain event, the faster and harder the orange was pushed to the north bank. Most of the time the orange would make it out of the whirlpool after one turn but some would spiral erratically before moving down stream. None of the five orange thrown in Eslava Creek plunged under the surface as they passed the drainage ditch entrance. Because the oranges in Eslava Creek spiraled it was hard to judge how quickly they were moving. Of the four oranges thrown in Eslava Creek after the rain event, the oranges made the 60 meter journey in 2 minutes 12 seconds, 1 minute 52 seconds, 2 minutes 54 seconds, and 2 minutes 45 second, making the average speed 2 minutes 15 seconds to travel 60 meters downstream. The oranges in the drainage ditch moved much faster and more directly in the ditch until they entered Eslava Creek. It was difficult to see the orange until the last 18 meters of the drainage ditch. The speed of the oranges in the last 18 meters of the drainage ditch was 1 meter per second. The oranges that made it into Eslava Creek plunged as they entered the Creek and resurfaced near the north bank and made the counter clock wise turn before continuing down Eslava Creek as shown in Figure 3.

Eslava Creek must be modified in order to break the eddy that is in place. The process of modifying Eslava Creek will be expensive but the cost of doing nothing may be more costly. If modifications are done now, it will be possible to save Eslava Creek Parkway from collapsing from an over steepened bank due to erosion. The road collapsing could end in a costly lawsuit if anyone were to get hurt on the road above. The drainage ditch entrance must be modified before more erosion is done in the next rain event and we can learn to do it correctly from other

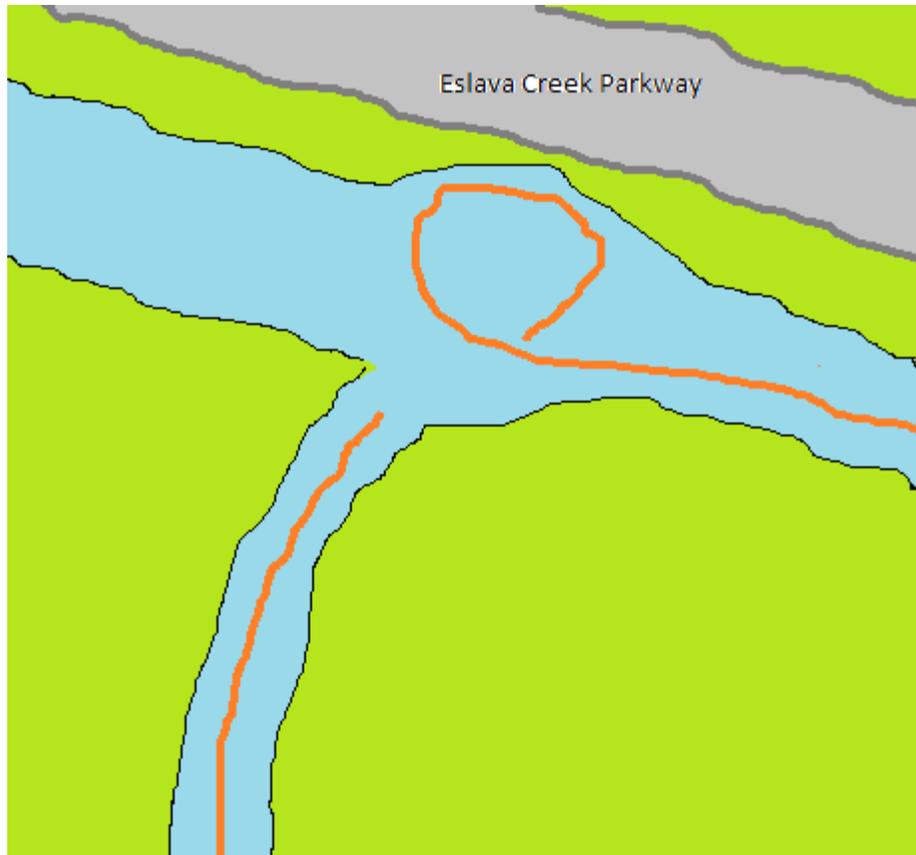
Figure 3.

The orange line represents the orange's path as it moved down the drainage ditch into Eslava Creek. The break in the line represents where the orange plunged beneath the surface of the water and was not visible. Again, the north bank erosion seems to be a direct result of the current pattern.
