## **MARSH DEGRADATION AT THE MOUTH OF MOORE CREEK**

**Hunter Winstanley**, Department of Earth Sciences, University of South Alabama, Mobile, AL 36688. E-Mail: hew501@jaguar1.usouthal.edu.

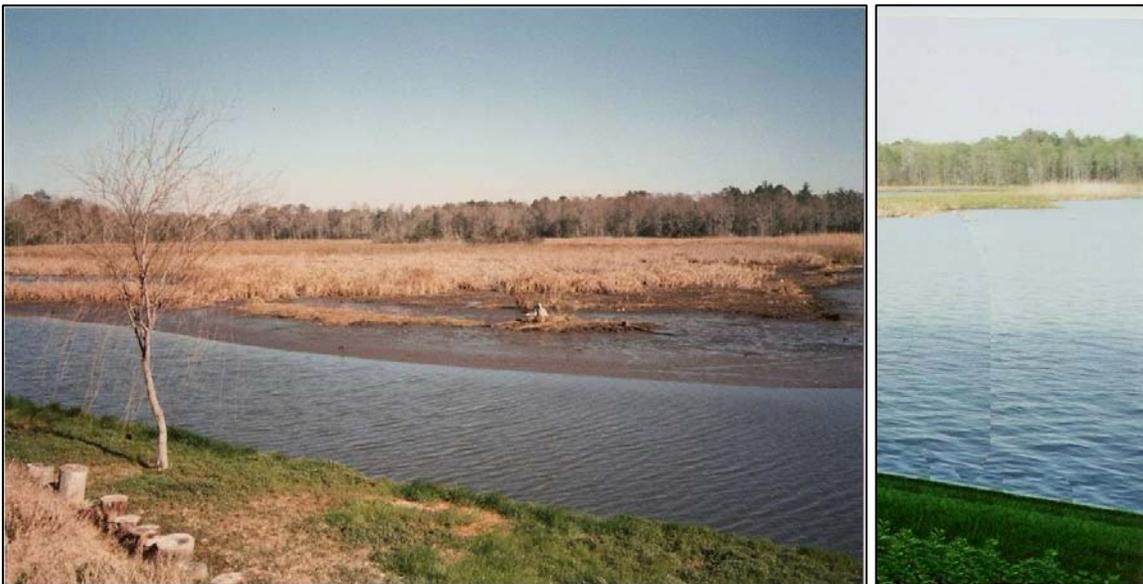
**Figure 2. Photo from 1995 on left and 2009 photo on right**

The study area is a small area of marsh located directly at the mouth of Moore Creek (Fig. 1). In 1995, this marsh extended very close to a house located on the water in mouth of the creek. However, now the marsh is almost completely disappeared (Fig. 2).

These pictures are taken from approximately the same location at both time periods (Fig. 2). It is easy to see how this marsh has degraded in just fourteen years.

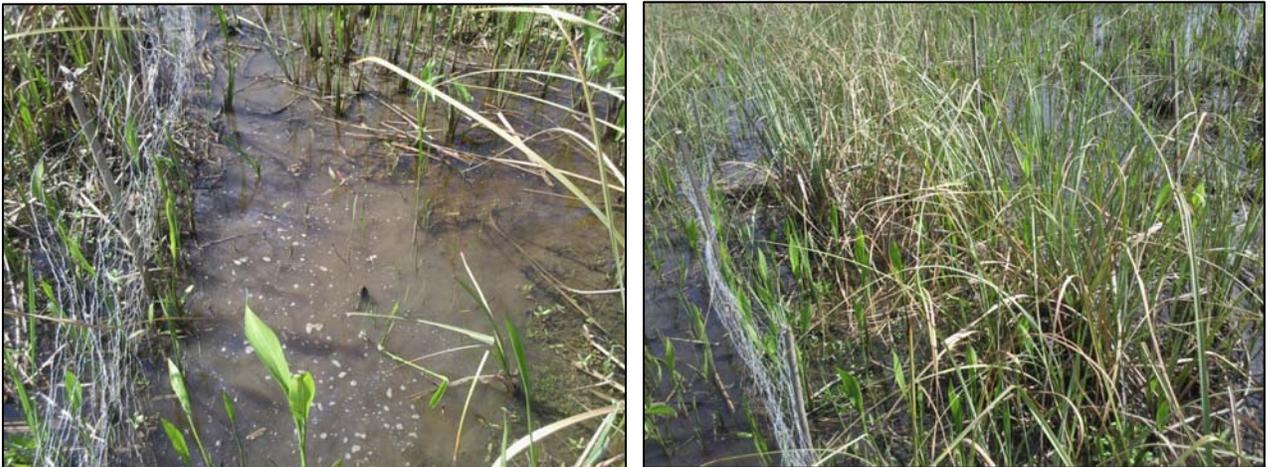
**Figure 3. Left photo shows bare mud outside the fence, right picture shows healthy vegetation inside the fence.**

A few weeks after the fence was built, I visited the marsh to investigate the condition of the vegetation inside and outside of the fenced in area. As expected, the

vegetation on the inside of the fence remained completely unharmed, and the vegetation on the outside was damaged. Small animal footprints were also found in the muddy marsh grounds. These footprints are believed to belong to nutria. Thus, the eaten vegetation outside the fence, and the unharmed vegetation inside the fence proves that nutria are present (Fig. 3). It also indicates that they are the reason for the marsh degradation in the mouth of Moore Creek.

Because Moore Creek and most of the Dog River Watershed lies within the Mobile city limits, shooting nutria is not a possibility. Hunting is not allowed within the city limits. Therefore, the best method for ridding the area of nutria is by trapping them. Trapping is a safe and effective manner to lower the numbers of these rapidly expanding rodents in the Dog River Watershed (Association of Fish and Wildlife Agencies, 2009).

Marshes at the mouth of Moore Creek in the Dog River Watershed have been degrading for quite some time. Before this study was conducted, the source of the problem had been unidentified. However, the culprit is no longer a mystery. The results of the investigation and the study of the marshes clearly show that nutria are the cause of the disappearing marsh in Moore Creek. Trapping is an effective method that must be used along the marshes at the mouth of Moore Creek in order to prevent further loss of marshes.

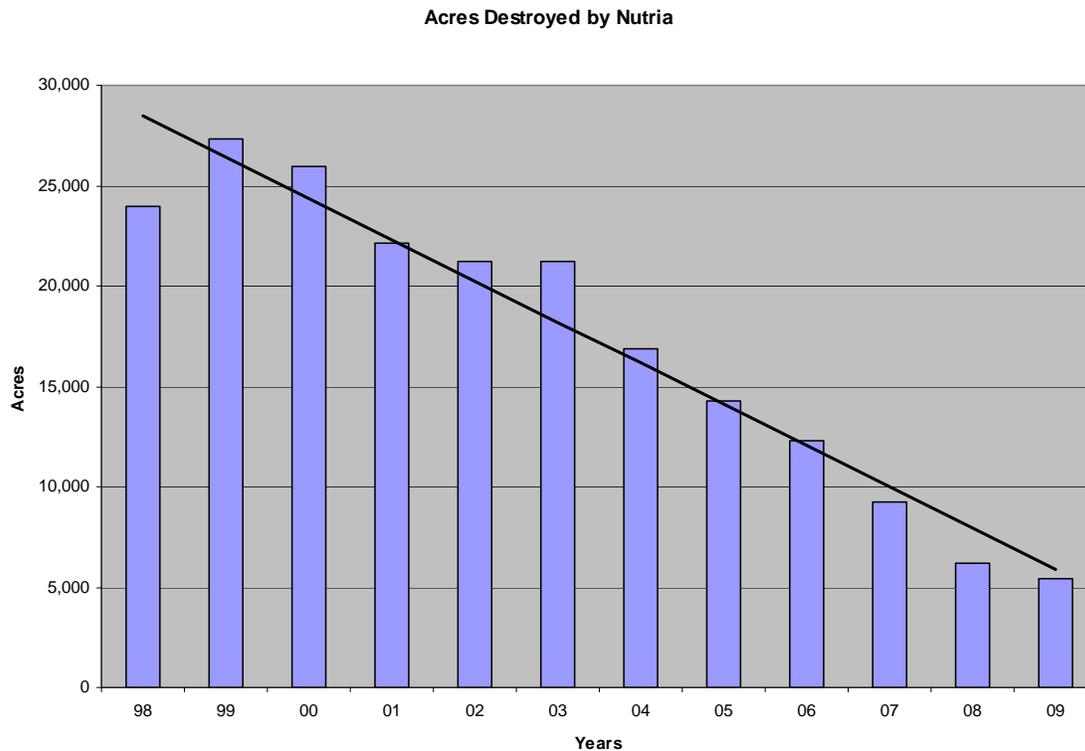
**Figure 4. Graph showing the decrease in marsh destruction brought about by the nutria control program in Louisiana.**

The marsh at the mouth of Moore Creek is degrading because of a nutria infestation. Across the country, nutria have been responsible for degrading marsh for decades. They have been a serious problem in the state of Louisiana, where their numbers are the highest. (*Nutria in Louisiana*, 2008) The Coastwide Nutria Control Program, created by the Louisiana Department of Wildlife and Fisheries, has effectively lowered the number of damaged marshes over the last decades. Figure 4 shows how the number of damaged marsh sites, and acres damaged has decreased since 1998 (Coastwide Nutria

Control Program, 2009). The Coastwide Nutria Control Program has saved thousands of acres of marsh over the last decade in Louisiana. The program shoots and kills countless nutria every year to prevent the animals from further overpopulating and endangering more marshes.
