ANALYZING AND SAMPLING LITTER ALONG MONTLIMAR CANAL

Marine Karapetyan, Department of Geography, University of South Alabama, Mobile, AL 36606. E-mail: hyemarqush@aol.com. Analyzing and Sampling Litter along Montlimar Canal.

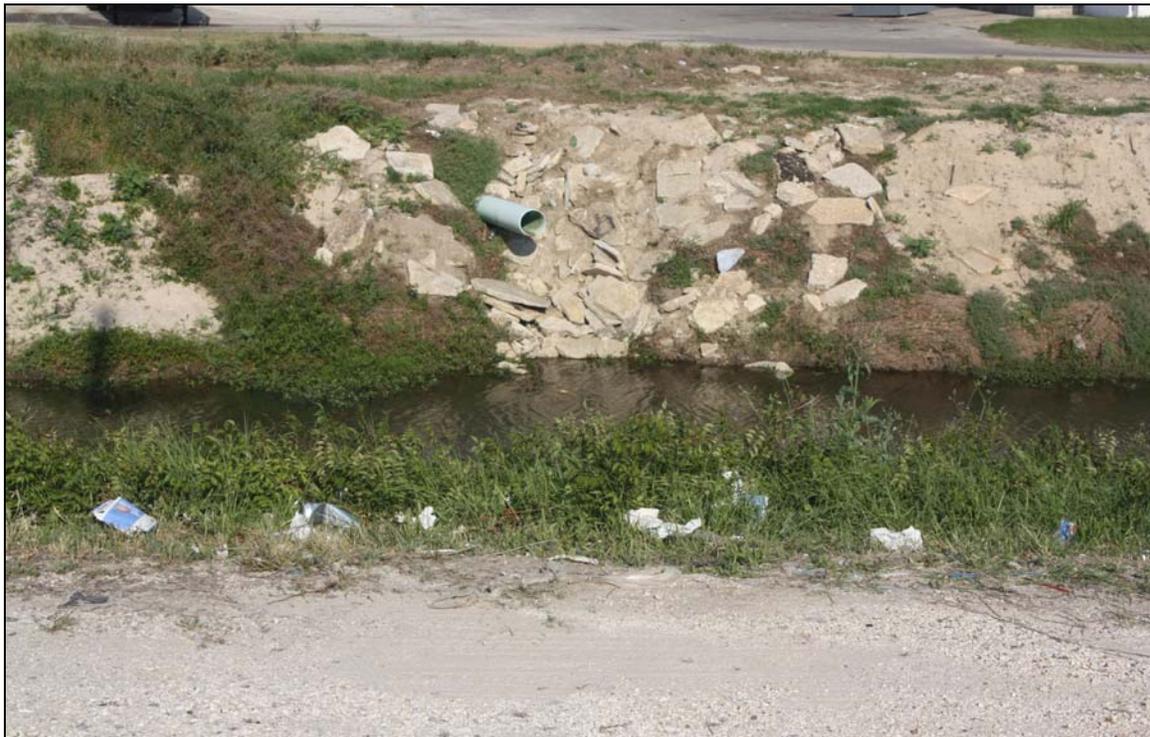
Figure 3: Commercial trash caught on the outer banks of the canal on Airport Blvd.

After thoroughly examining sites for litter and trash, it became apparent which areas were suffering most from litter. As Table 1 below shows, two out of the six locations studied proved to have very serious litter issues. The first location, Site 1 (Airport Boulevard), was one of those two. Located in a dominantly commercial area, it had primarily commercial litter from surrounding restaurants, shops, and gas stations along the banks (Figure 3). However, moderate amounts of personal litter were found as well from an apartment complex located adjacent to the stream.

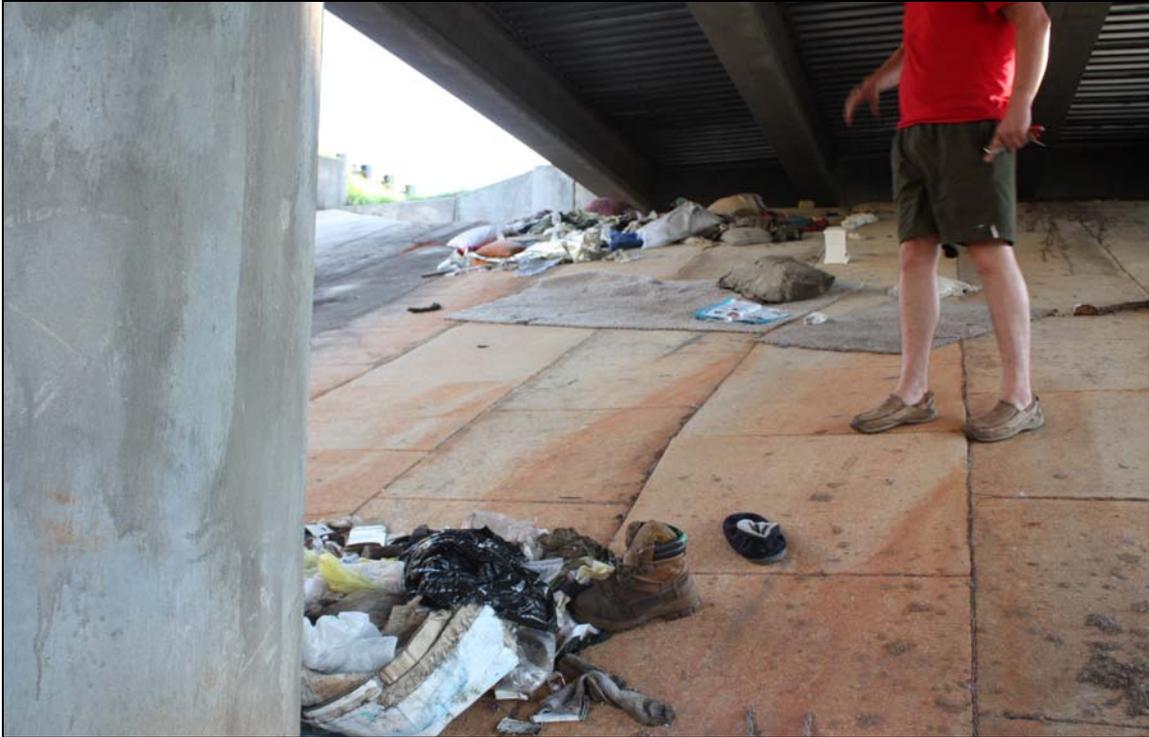
Figure 4: Heavy litter found under bridge produced by homeless groups.

Site 5 (Government Blvd./ I-90) had an overwhelming amount of personal litter from the homeless residing under the bridge, and was the second area for heaviest litter present. Massive trash bags full of garbage, clothes, shoes, mattresses, food containers, paper, cans, plastic bottles, towels, etc. were found directly under the bridge as seen in Figure 4. Walking away from the bridge, litter was still heavily prevalent, but the majority of it was plastic, and glass bottles on either side of the bridge (Figure 5). Finally, at site 6 (Azalea Rd/ Halls Mill Rd), a medium level of litter was present, mainly from

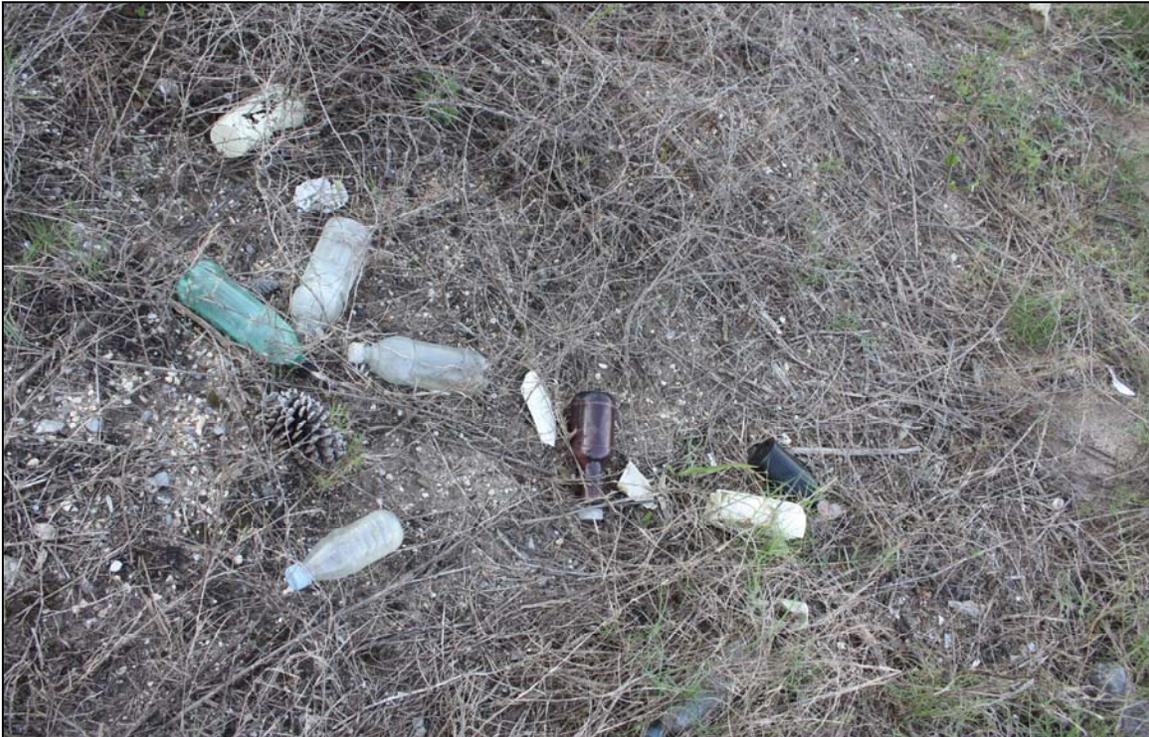
Figure 5: Plastic and glass bottles contributed the greatest amount of litter away from the bridge on Site 5.
