DERELICT BOATS IN DOG RIVER, ALABAMA

Tela V. O'Rourke, Department of Earth Sciences, University of South Alabama, Mobile, AL 36688. E-MAIL: tkv601@jaguar1.usouthal.edu. Derelict Boats in Dog River, Alabama.

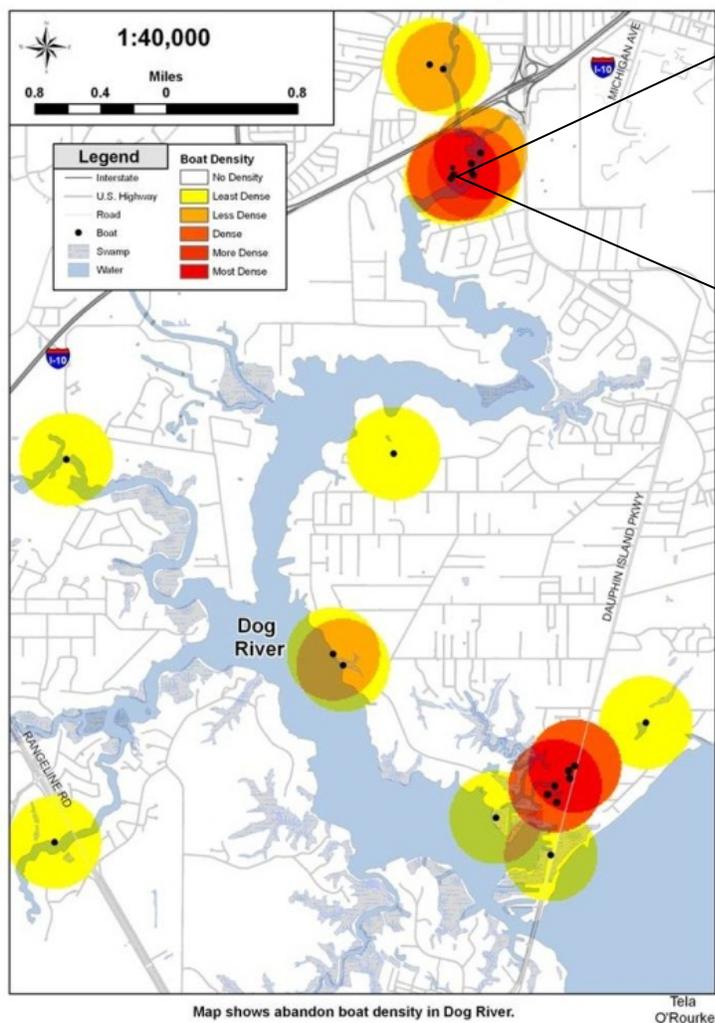
Figure 3. The vessels above are located near the mouth of Eslava Creek. An old yacht and burned pontoon boat are left neglected in this low-income

From the data collected, I was able to determine the locations of derelict boats on Dog River and where the density of abandoned boats is the highest. Two locations were substantially higher than other areas. The map above (**Figure 3**) shows the density of boat locations along my reconnaissance of Dog River. The area in red at the top of the map is located in a low-income neighborhood. Within a 1500ft radius, there were seven derelict boats in the location. Another area with a high density of derelict boats was around the marinas close to Dauphin Island Parkway. This location, six derelict boats were found within 1500ft, and nine within 3000ft.

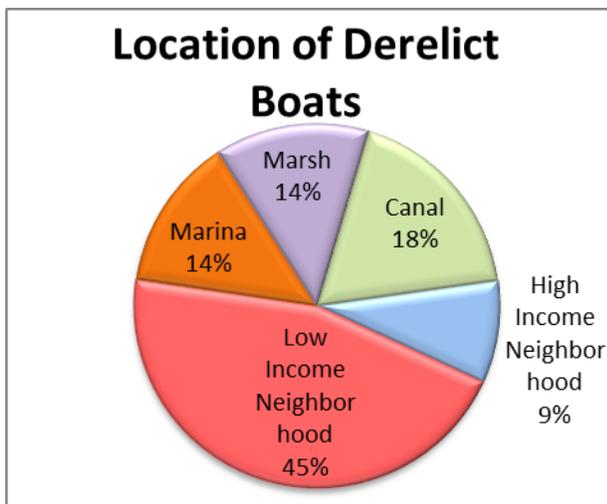
The most common type of craft found throughout the entire Dog River area where both small and large fishing boats left on the shoreline of docks or stuck in the marsh. Marinas and canals made up nearly 32% of boats found neglected, not to include canals in areas of low-income neighborhoods. Watercrafts in small water alleyways and near shorelines in residential neighborhoods are safety hazards to people who intend to use the river as a recreational source. Areas of tight canals and tributaries, derelict boats become obstacles to avoid or navigate around. In shallow waters throughout Dog River, this can create boating accidents and cause personal injury to the people involved. Throughout my reconnaissance of Dog River, twenty-three derelict water vessels were found in total.

Figure 4. Pie chart indicated location of derelict boats

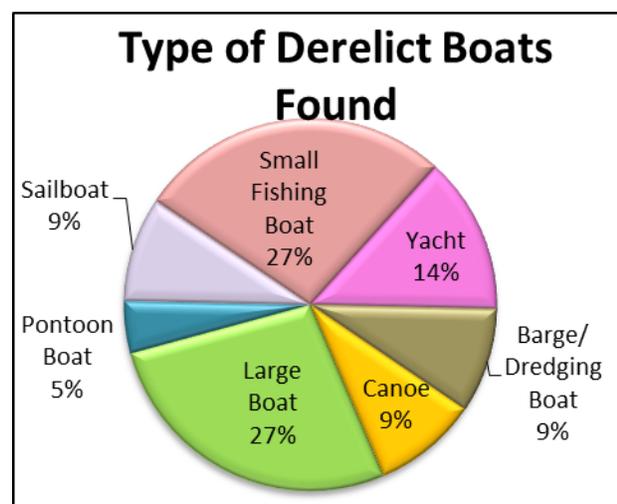
Figure 5. Pie chart indicates type of derelict boats found
