INTERCEPTION LOSS IN A TRIBUTARY OF MILKHOUSE CREEK

Joel C. Plagge, Department of Earth Sciences, University of South Alabama, Mobile, AL 36688. E-mail: jcp403@jaguar1.usouthal.edu

Keywords: Milkhouse Creek, interception, rainfall

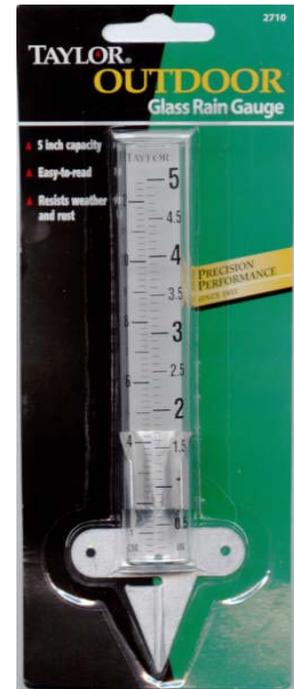
To test interception loss, I placed rain gauges in two different areas in order to capture rainfall. The gauges are Taylor Model 2710 Glass Rain Gauges with a 5 Inch capacity (Figure 1). They were mounted on planks of wood twenty-one inches long and three inches wide. This was in order to prevent them from being carried away by running water. Twenty rain gauges were constructed in this manner. Ten of them were placed in each area on March 25, 2009. One area in which rain gauges were placed was the old growth forest of the tributary area; the other was in the vicinity of a 100-foot power line right-of-way.

Figure 1: Photo of the type of rain gauge used during the research

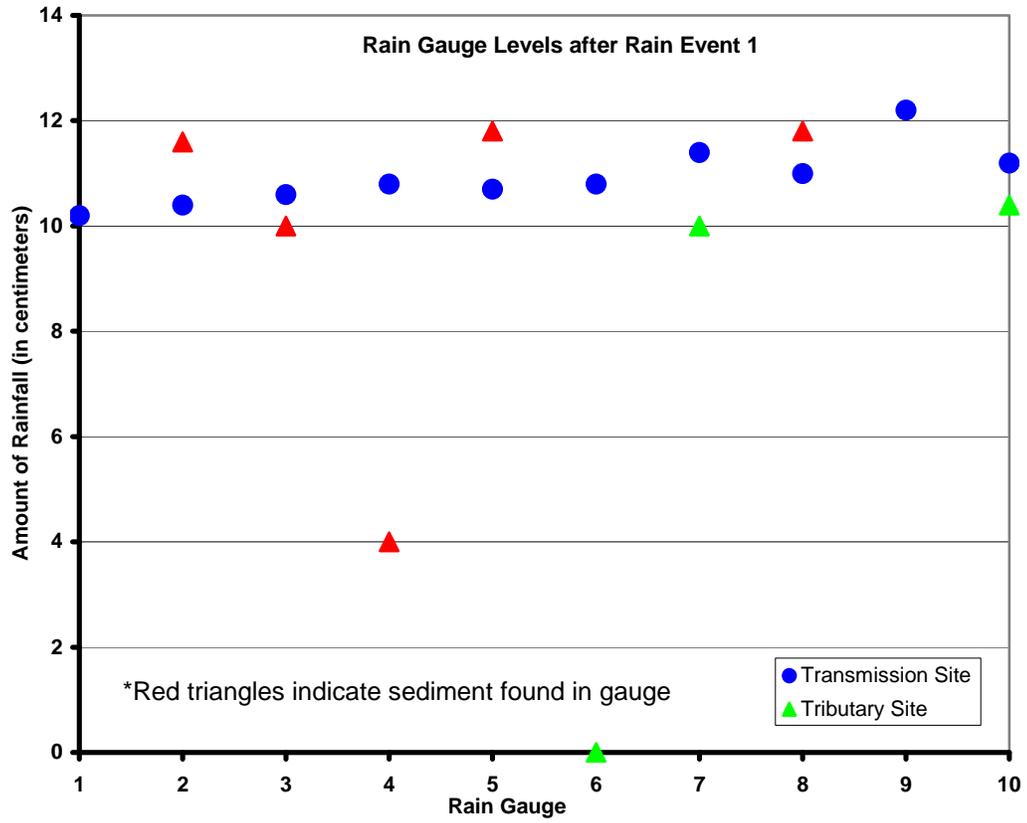
Figure 4: Graph showing levels in rain gauges after rain event 1

Three rainfall events occurred during the course of this research. The first rainfall event occurred between March 26 and 27, 2009. This was a long, hard storm that produced a large amount of rain. The rain gauges were checked on March 29, 2009. In the tributary site, two of the rain gauges were missing, and a third was uprooted. The other

seven were still in place and had captured rainfall. Of the seven still standing, 5 of them had sediment in them. All the gauges in the transmission site were still in place and had captured rainfall. The median rainfall amount for this event was 10.75 centimeters. A Chi Square test could not be performed for this set of data since the gauges were flooded and contained as much as eight centimeters of sediment in them. The second rainfall event occurred on April 2, 2009, this was a shorter duration storm, and rain was captured in all gauges at both sites. The gauges were checked on April 3, 2009. The median for this data was 3.2 centimeters. Several of the gauges in the tributary site were again flooded and contained sediment. A Chi Square test could also not be performed because of this. The third rain event occurred on April 13, 2009. This was the shortest and lightest rain event. The gauges were checked on April 16, 2009. The median for this data was 3.5 centimeters and the Chi Square value was 14.40. This value was above the critical value also, meaning that there was a difference in rain between the two sites. The data was then put into graphical form in Excel (Figures 4, 5, 6).

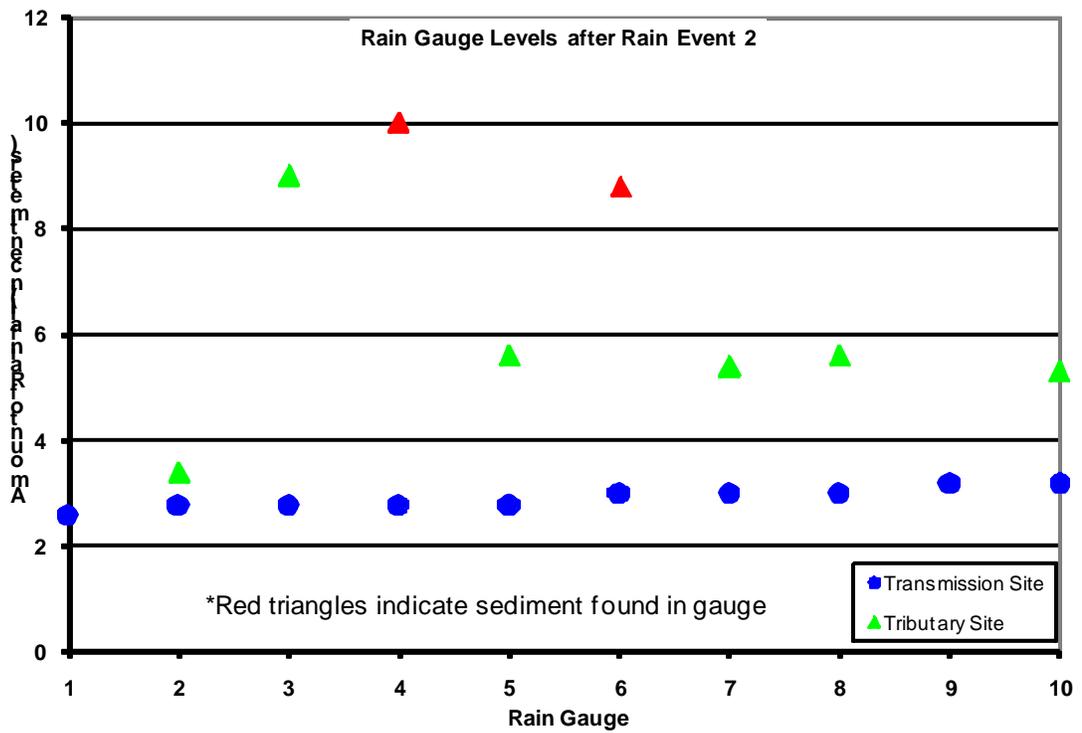
Figure 5: Graph showing levels in rain gauges after rain event 2

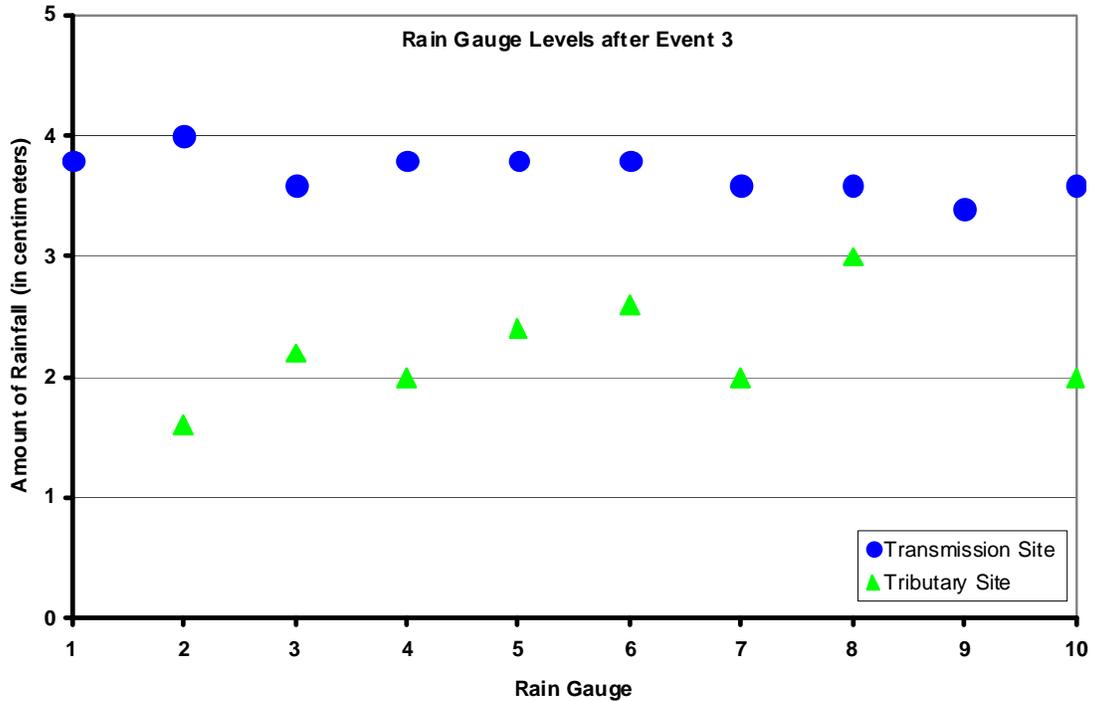
Figure 6: Graph showing levels in rain gauges after rain event 3.
