SEARCHING FOR SEDIMENT SOURCES IN SPRING CREEK

Christopher Frederick, Department of Earth Sciences, University of South Alabama, Mobile, AL 36688. E-mail: cjf702@jaguar1.usouthal.edu.

Keywords: stream, erosion, sediment

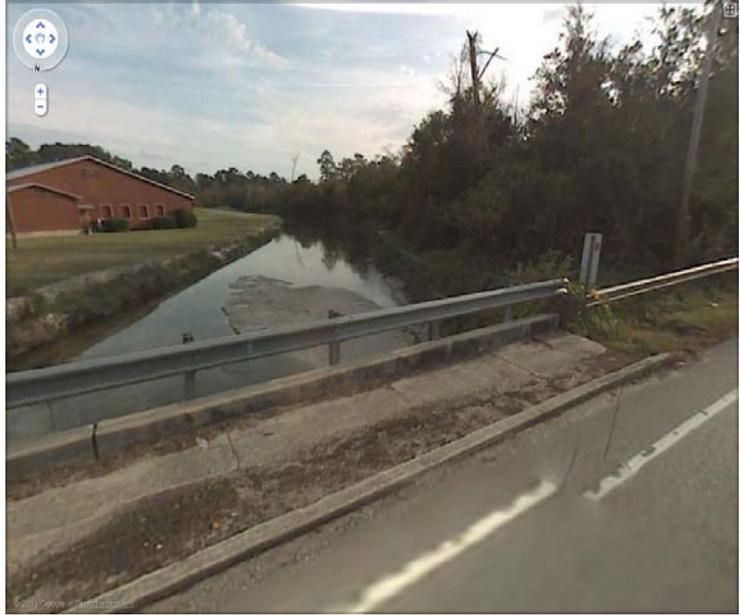
Figure 2: Spring Creek
(Google Earth 2011)

than should be expected (Oertel 2003). Years after construction has been completed, the creek seems to have taken on a more natural look, trying to defy the construction projects bounds. This sediment is a major issue however, it builds up so rapidly, yet no source has been identified to prevent this problem. Dredging this sediment so often carries extreme costs, why not stop the sediment at the source? The city of Mobile, Dog River Clearwater and other related organizations should be concerned about the massive amounts of sediment making its way into the small portion of swamp located behind the old Cock of the Walk restaurant. This sediment build up can be seen in Fig. 2.

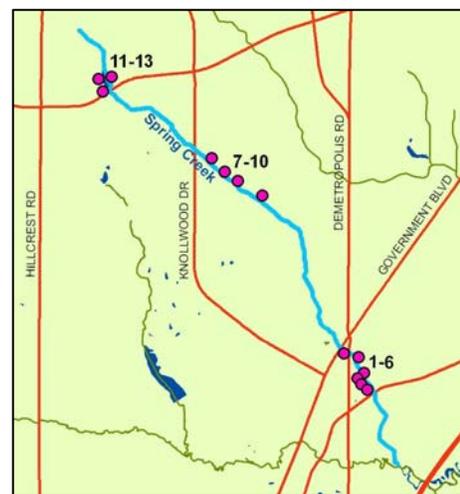
Figure 3: Spring Creek sample sites

A focus on the areas of likely sources was conducted in the field. 13 sites were selected based on previous factors, and allowable field conditions. Figure 3 shows the location of the sites selected. At each site on March 17, two 3.5inch nails were driven into the ground to a depth of three inches. Two were used for the purpose of redundancy and

accuracy. A small plastic ribbon was attached to one of the nails to help relocation efforts. On April 21, I went back to each site and recovered the nails, recording amounts of erosion, or deposition, by recording the nail head's new height above the ground. Table 1 shows the site descriptions, and is referred to in my discussion.

Table 1: Spring Creek site descriptions

Site	Description
1	Stream bank (channelized)
2	Stream bank (channelized)
3	Stream bank (channelized)
4	Sand bar in creek (channelized)
5	Stream bank (channelized)
6	Stream bank (channelized)
7	Stream bank (natural)
8	Stream bank (natural)
9	Sand bar in creek (natural)
10	Stream bank (natural)
11	Construction silt fence
12	Stream bank (cement)
13	Construction silt fence
